INL/EXT-05-00381

***Oil Bypass Filter Technology Evaluation  
Tenth Quarterly Report  
January–March 2005***

**Idaho National Laboratory  
Transportation Technology Department  
Idaho Falls, Idaho 83415**

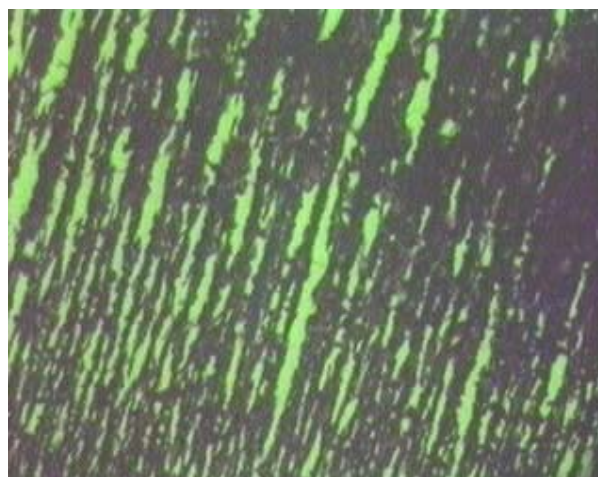
Idle Test Ferrograms								
Bus Number	Oil Source	Sample Date	NTS Sample Number	Test Stage	Total Miles and Hours on the Oil	Magnification	Photograph Number	Region of Slide
73432	By pass residual	12/20/05	87759	baseline	79053 miles	100x	87759-A	Entry
<b>Comments</b>	Three ml of oil from the neutral base oil after ultrasonic cleaning of the full flow filter media is the oil tested with this ferrogram. Ferrogram shows a moderate amount of fine (<10 µm) ferrous particulate, typical of normal rubbing wear.							
<b>Special Features</b>	Very fine ferrous debris. Density 5
